Situation Photo Log

Tuesday, March 20, 2012

Kalamazoo River / Enbridge Spill

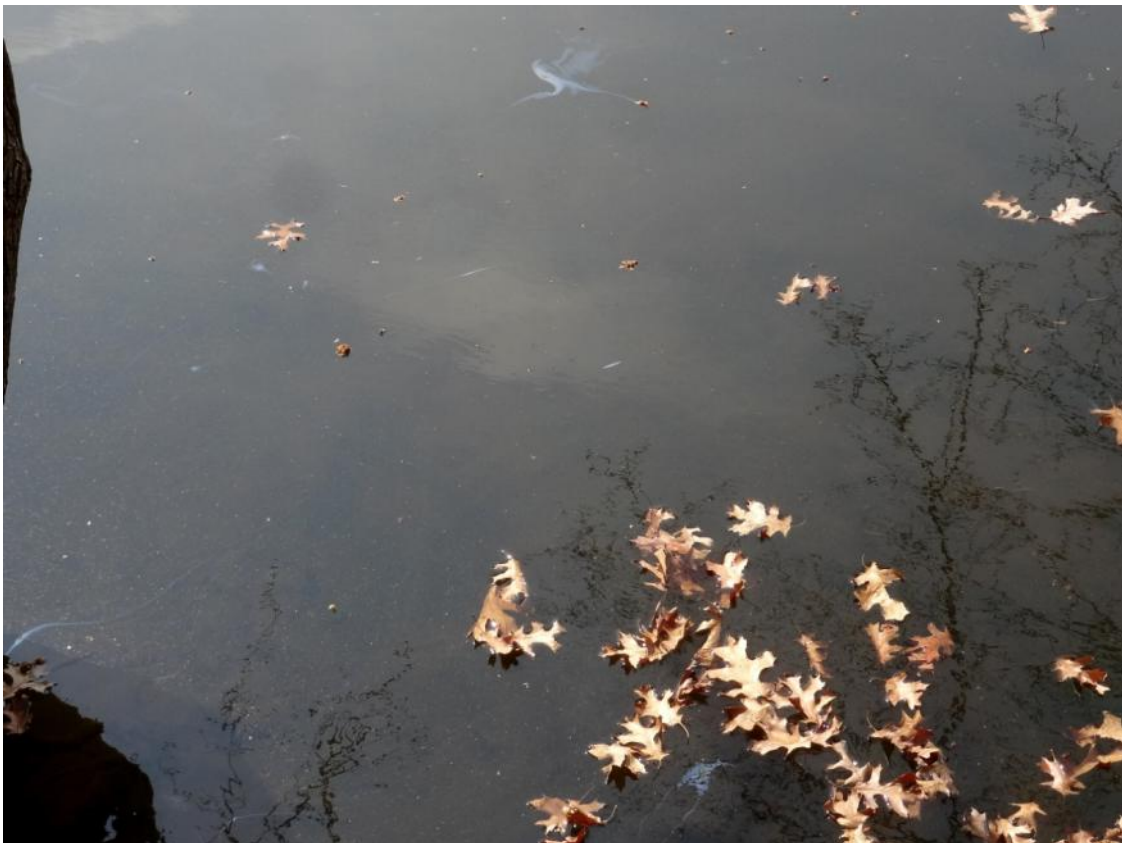
24. MP14.75, C5 Boat launch sheen observed.

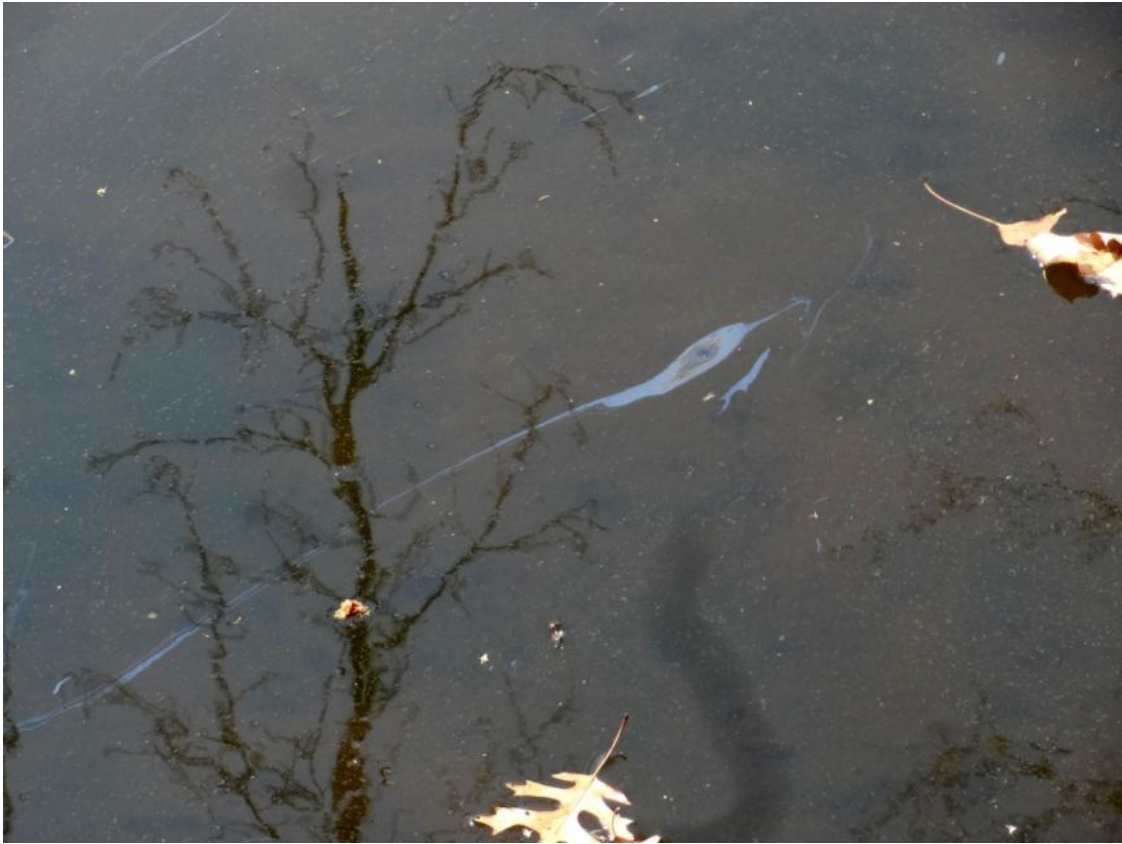
25. MP14.75, C5 Boat launch sheen observed.

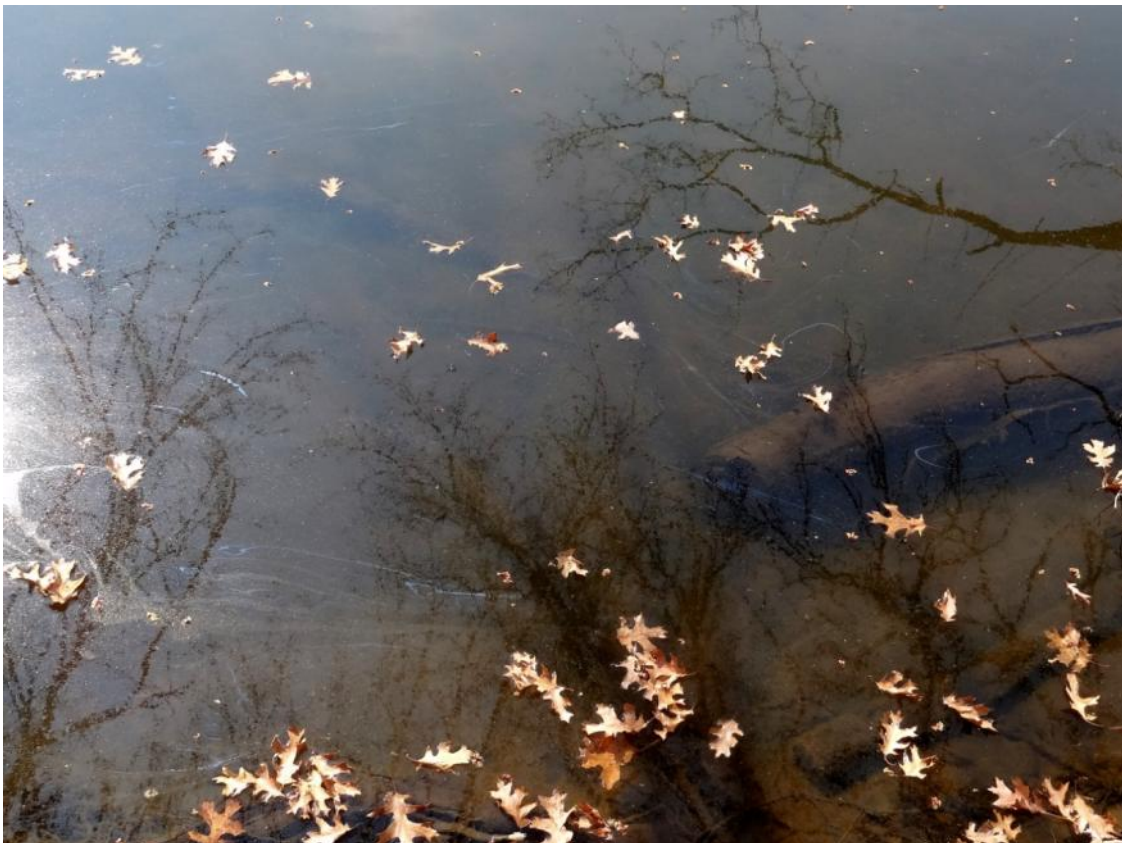
26. MP14.75, C5 Boat launch sheen observed.
